Manhole Inspection Summary

Manhole # S17EE2013MH

Insp Date: **7/13/06 2:36 PM**

Location Address: **5805 LOCHLEA RD**

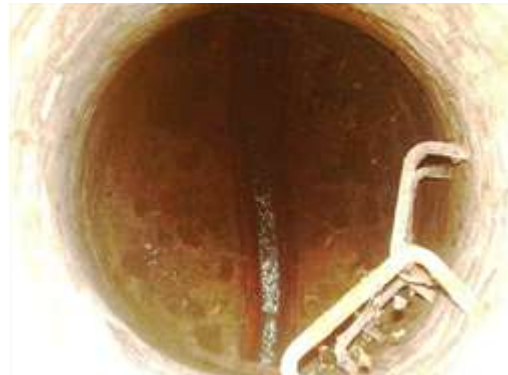
Top View

Corroded steps. Bench debris.

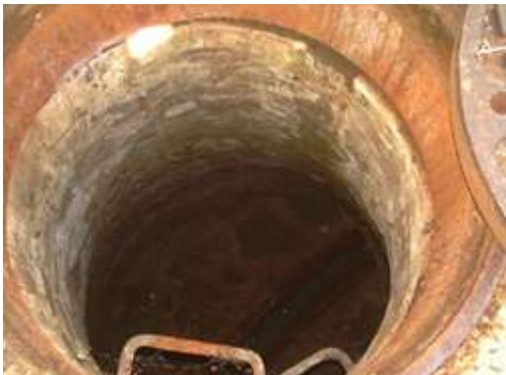
Defect

Frame leaks. Adjustment and Barrel infiltration.

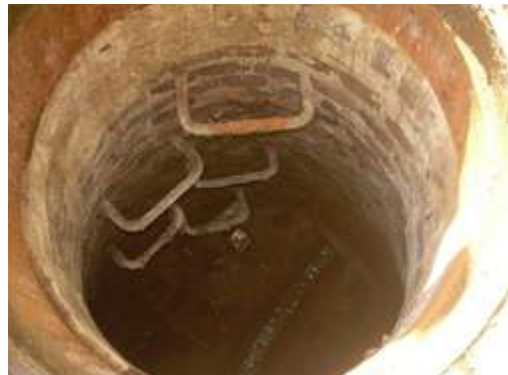
Defect

Frame leaks. Adjustment and Barrel infiltration - other side.

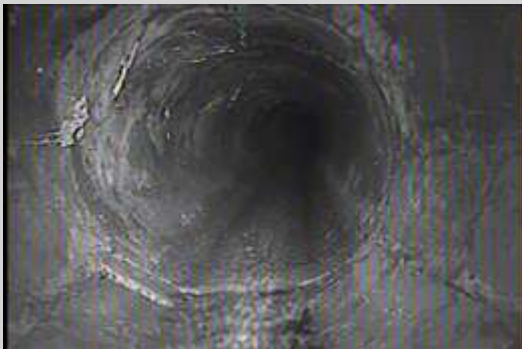
8 in. Circular Gravity Sewer Pipe In @ 6 O'Clock

Infiltration: **Evidence** Pipe Seal Cond: **Cracked**
